Polishing-induced contamination of fused silica optics and laser induced damage density at 351 nm

Abstract: In this paper we study the effect of contamination induced by fabrication process on laser damage density of fused silica polished parts at 351 nm in nanosecond regime. We show, owing to recent developments of our raster scan metrology, that a good correlation exists between damage density and concentration of certain contaminants for the considered parts.

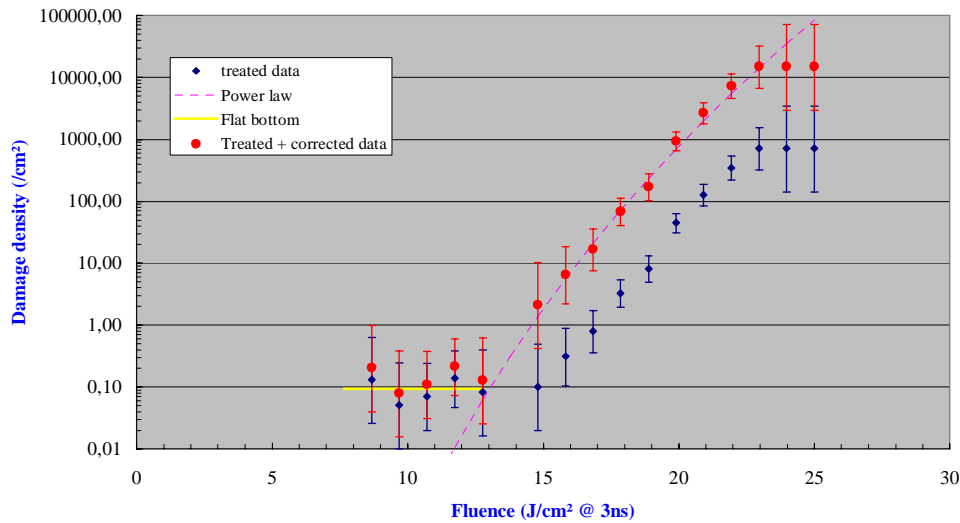
Fig. 1 : Damage density versus fluence. Sample B2. Blue and red points represent respectively treated and “treated + corrected” data. The corrective factors are 1.5 and 21 respectively for the flat bottom and the power law.

Figure 1 illustrates typical results obtained after complete analysis. Blue points correspond to the treatment described previously. Due to Gaussian beam profile and beam overlap between shots (about 66%), we have to take into account the beam shape to obtain an absolute result. On the graph, one can observe two behaviors. Below 15 J/cm², damage density is roughly constant and damage is not fluence dependent but based only on the defect density; we simply have to take into account the total irradiated area. Above 15 J/cm², damage density increases following a power law. In this domain, damage occurs at the beam maximum fluence and only the Gaussian top part of the profile is taken into account. In this

case, raw data are corrected by a factor that depends on the slope of the fluence law [17, 18]. Ultimately, red points represent the absolute result from the test.

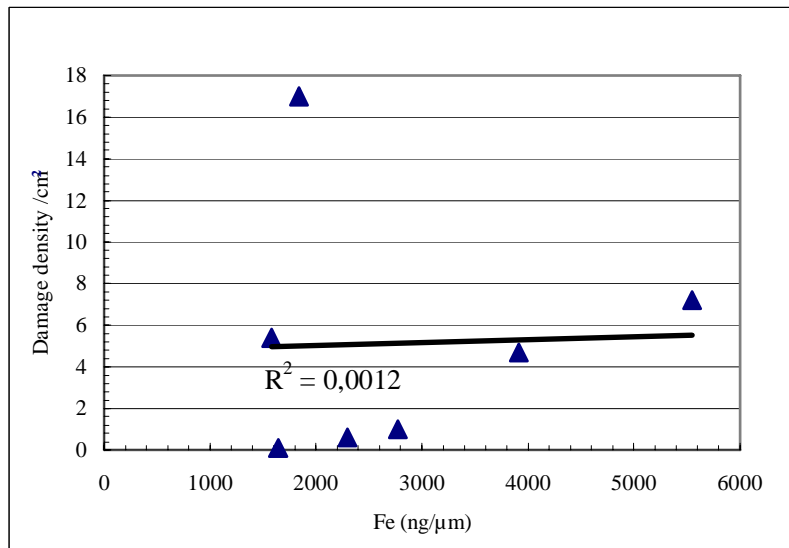
Fig. 5. Effect of Fe content on damage density.

Data are fitted with a linear law with a correlation coefficient of 0.99 approximately. At the opposite, Figure 5 presents the data for Fe where correlation between damage density and Fe concentration is very weak.

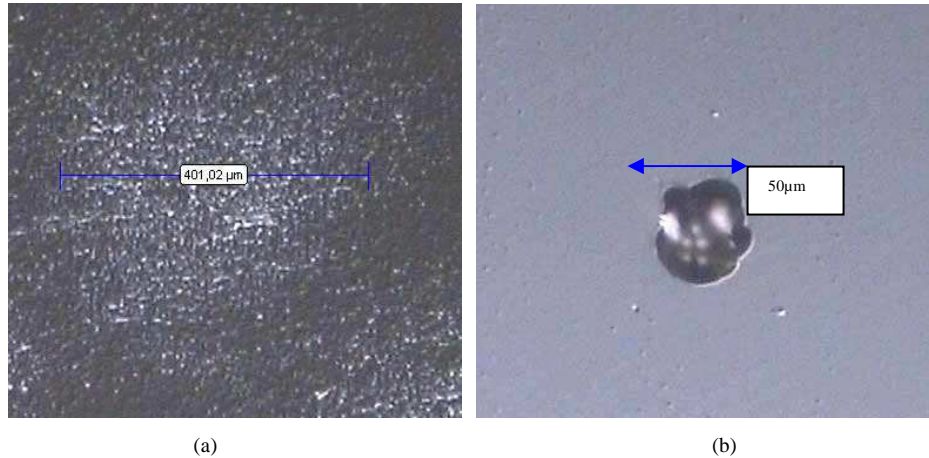
Fig. 6. (a) Gray haze damage, part B1 (b) typical damage morphology on part A4

We have also been trying to correlate the presence of cerium in the interface with damage morphology. On part B1 exhibiting very high cerium concentration in the interface, the "gray haze" damage morphology can be easily seen such as previously described by Kozłowski *et al.* [16]. Figure 6(a) shows such a gray haze damage like observed with a Nomarski microscope. When cerium content decreases, the gray haze morphology disappears to leave place to more classical small damage sites such as depicted in Figure 6(b). Some small damage clusters can be observed but no clear correlation has been seen between cerium concentration and quantities of these clusters like damage sites.
